<b>1. REPORT DATE (DD-MM-YYYY)</b> 02-06-2002		<b>2. REPORT TYPE</b> Technical Paper		<b>3. DATES COVERED (From - To)</b> 01-01-2002 to 02-06-2002	
<b>4. TITLE AND SUBTITLE</b>  Recent Advances in Matting Technology for Military Runways				<b>5a. CONTRACT NUMBER</b> 8637-98-C-6001	
				<b>5b. GRANT NUMBER</b>	
				<b>5c. PROGRAM ELEMENT NUMBER</b> 6112	
<b>6. AUTHOR(S)</b>  Maj. Dov Dover, P.E., I.A.F., Dr. Mark Anderson, P.E., and Dr. Randall W. Brown, P.E.				<b>5d. PROJECT NUMBER</b> 4915	
				<b>5e. TASK NUMBER</b> D11A	
				<b>5f. WORK UNIT NUMBER</b>	
<b>7. PERFORMING ORGANIZATION NAME(S) AND ADDRESS(ES)</b>  Israeli Air Force (on assignment to AFRL/MLQD)   Applied Research Associates, Inc. Engineering and Science Division P.O. Box 40128, Tyndall AFB, FL 32403				<b>8. PERFORMING ORGANIZATION REPORT NUMBER</b>	
<b>9. SPONSORING / MONITORING AGENCY NAME(S) AND ADDRESS(ES)</b>  Air Force Research Laboratory Airbase Technologies Division, Deployed Base Systems Branch 139 Barnes Drive, Suite 2, Tyndall AFB, FL 32403				<b>10. SPONSOR/MONITOR'S ACRONYM(S)</b> AFRL/MLQD

## Recent Advances in Matting Technology for Military Runways

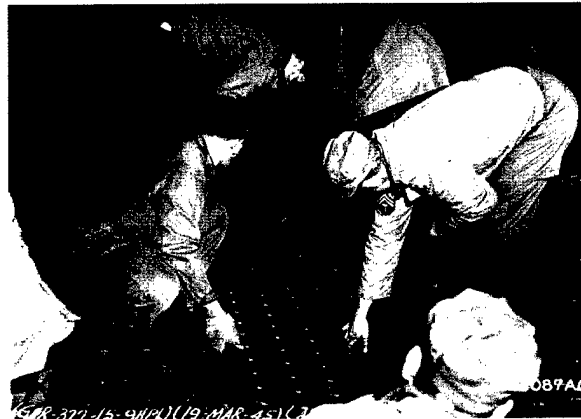
Figure 1. Pierced Steel Planking (PSP) being installed at night by men of the IX Engineer Command at an Air Force Base in Germany (circa 1945).

Pierced Steel Planking (PSP), also known as Marston Matting, was initially tested at Langley Field, Virginia, in 1940 and was in wide use even through the Korean War. Installation of PSP is shown in Figure 1. PSP proved to be very versatile. It was comparatively light, yet fairly rigid and very transportable. The simple hook design on the plank edges made assembly a fast and relatively easy undertaking, and minor replacement repairs usually ended up requiring only two men to accomplish. When major repairs were necessary, large sections of planking could actually be rolled up and removed and replaced as appropriate. A major drawback that eventually brought about its replacement was the development of drainage problems. The holes in the planking served to reduce weight but also resulted in an undesirable "pumping" action that caused rapid base course failures in wet climates (such as Southeast Asia). By the end of World War II, enough PSP had been manufactured to construct nearly a thousand 46 m x 1.5 km (150 ft x 5,000 ft) runways (as shown in Figure 1).

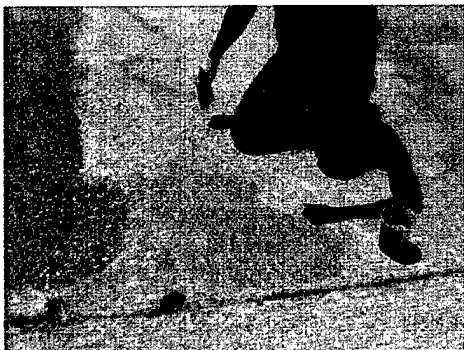
(c) Priming repair shoulders

**Test Case 1 Procedure.** Figure 5 illustrates the entire procedure for Test Case 1, including the installation of the unreinforced ESC FOD cover, and testing to determine the capability of the ESC FOD cover to withstand loading by the F-15 aircraft. Figure 5a shows a test crater which has been repaired by standard Air Force procedures (*Rapid Runway Repair, 1999*), but just before a FOD cover would normally be applied. Figures 5b and 5c show special preparation needed to assure a good bond between the existing crater shoulder and the ESC, i.e., cleaning the shoulder with compressed air and then applying primer. Figure 5d shows the AFRL ESC equipment previously shown in schematic form in Figure 4. The ESC equipment is trailer mounted for easier use. Figures 5e and 5f show spraying the ESC to a thickness of 6 mm (1/4"), up to and including the crater shoulders, to create a monolithic, anchored FOD cover. Figure 5g shows the F-15 load cart (configured as previously discussed). Figure 5h shows the unreinforced ESC FOD cover after 150 passes of the F-15 load cart.

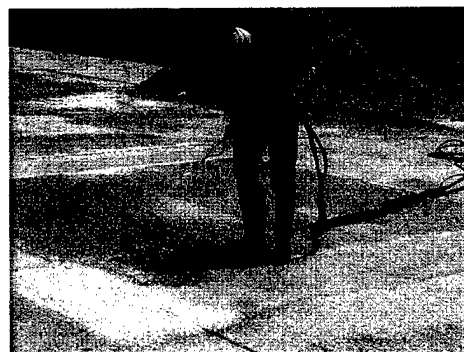
(e) Spraying to 6-mm ( $\frac{1}{4}$ ") thickness
